# Manhole Inspection Summary

Manhole # S41A\_\_041MH

Insp Date: **6/26/08 8:45 AM**

**Location** Address: **500 n caroline st**

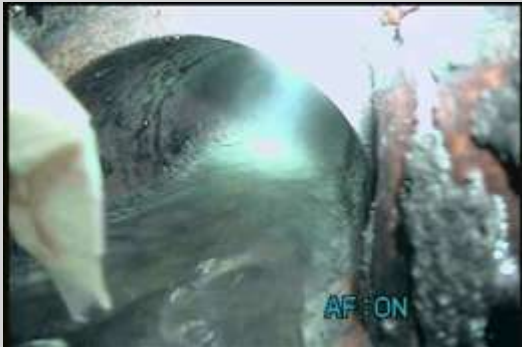
12 O'Clock Outflow

8 in. Circular Gravity Sewer  
Pipe Out @ 12 O'Clock

Pipe Material: **Clay** ☐ Pipe Lined

Invert Depth: **10.52** (ft.) Flow Characteristics: **Fast**

Deposits: ☒ None ☐ Mud ☐ Sludge ☐ Debris ☐ Grease

Infiltration: **None** Pipe Seal Cond: **Unknown**

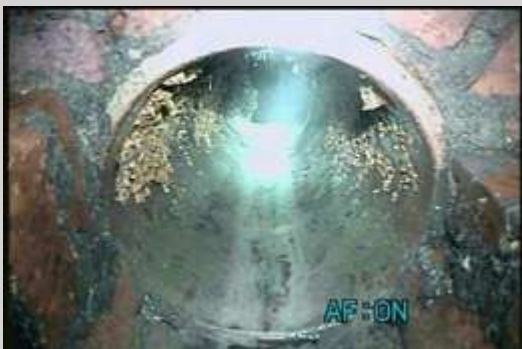
3 O'Clock Inflow

8 in. Circular Gravity Sewer  
Pipe In @ 3 O'Clock

Pipe Material: **Clay** ☐ Pipe Lined

Invert Depth: **10.09** (ft.) Flow Characteristics: **None**

Deposits: ☒ None ☐ Mud ☐ Sludge ☐ Debris ☐ Grease

Infiltration: **None** Pipe Seal Cond: **Unknown**

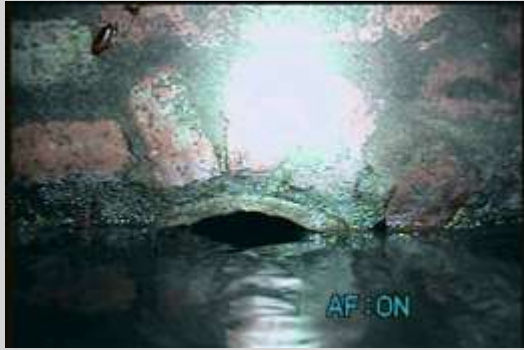
6 O'Clock Inflow

8 in. Circular Gravity Sewer  
Pipe In @ 6 O'Clock

Pipe Material: **Clay** ☐ Pipe Lined

Infiltration: **None** Pipe Seal Cond: **Unknown**
